September 15, 1960

LOCKHEED ELECTRA ACTION PROGRAM

LOCKHEED ELECTRA ACTION PROGRAM (LEAP)

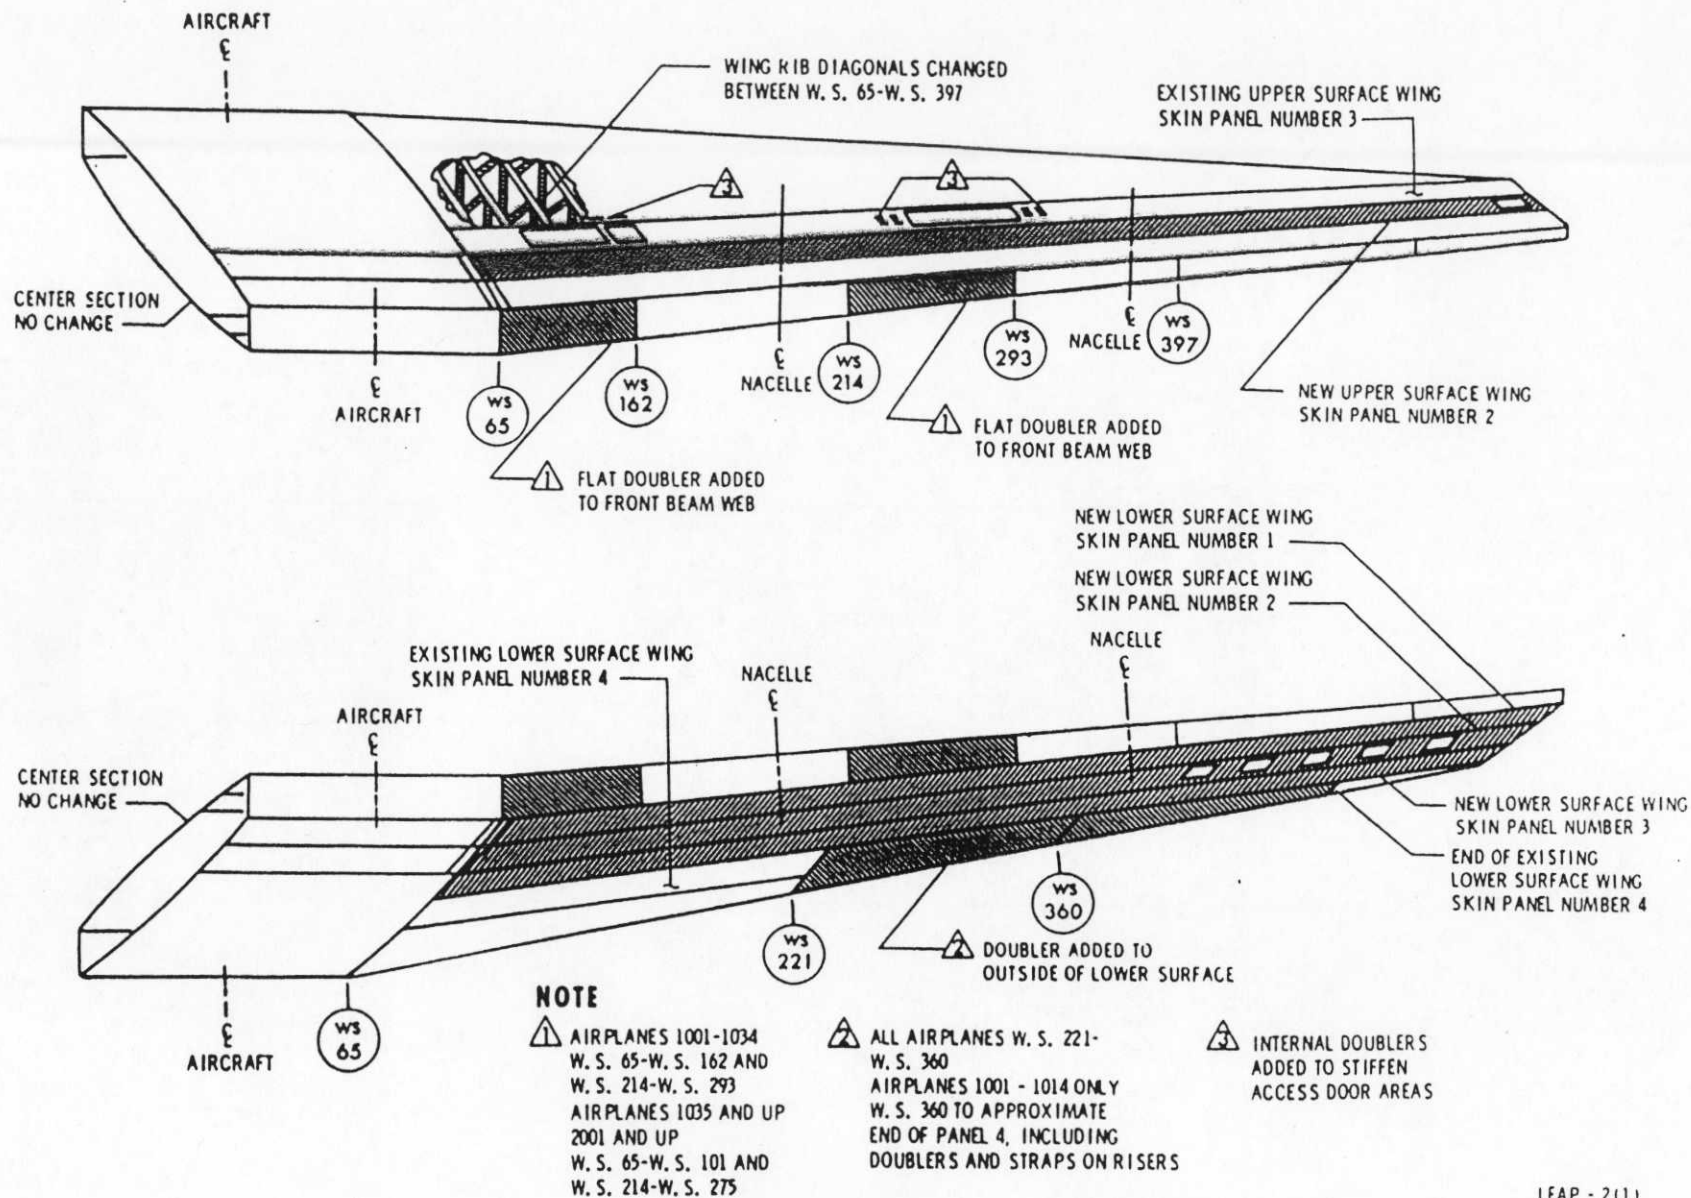
Wing Modification
Figure 2 (Sheet 1)

Upper wing panel number 2, left and right sides, will be replaced. The geometry of the new panel is similar to existing panels. The new panel will provide increased area since riser height and thickness, and skin thickness is increased.

Lower wing panels numbers 1, 2, and 3 left and right will be replaced. The geometry of the new panels is similar to existing panels. Riser height and thickness and skin thickness have been increased.

To reduce shear stresses and increase the torsional strength required between nacelles, an external doubler is added for all airplanes on the lower surfaces (left and right) from W.S. 221 to W.S. 360 extending from the forward edge of the number 4 panel to the rear beam. In addition, airplanes 1001 - 1014 will include a doubler (and straps on risers of existing panels) from W.S. 360 to W.S. 516 extending from the forward edge of the number 4 panel to the rear beam.

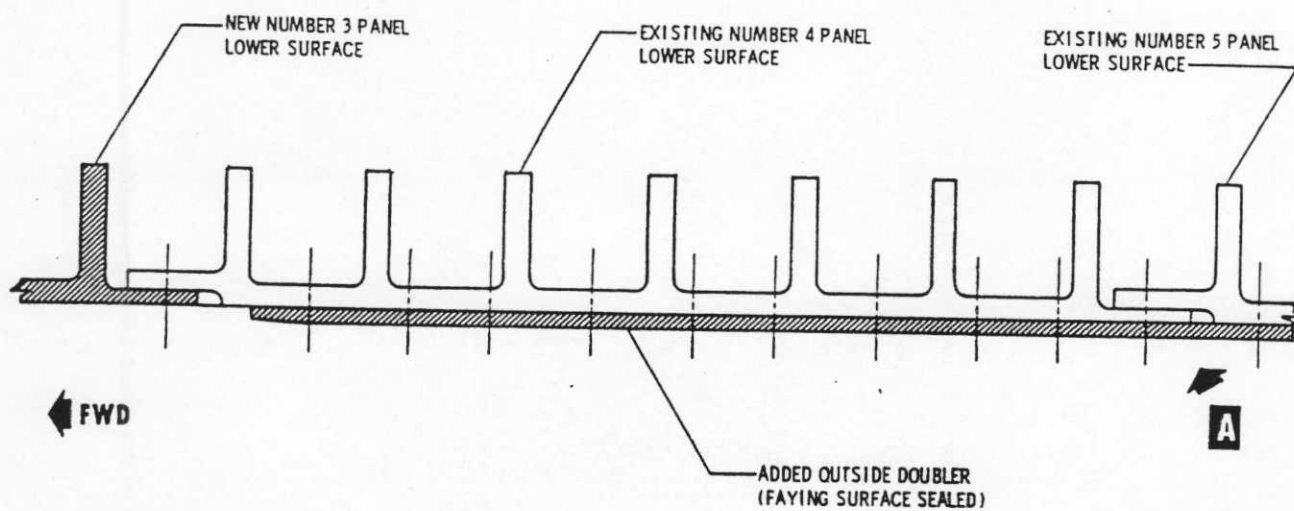
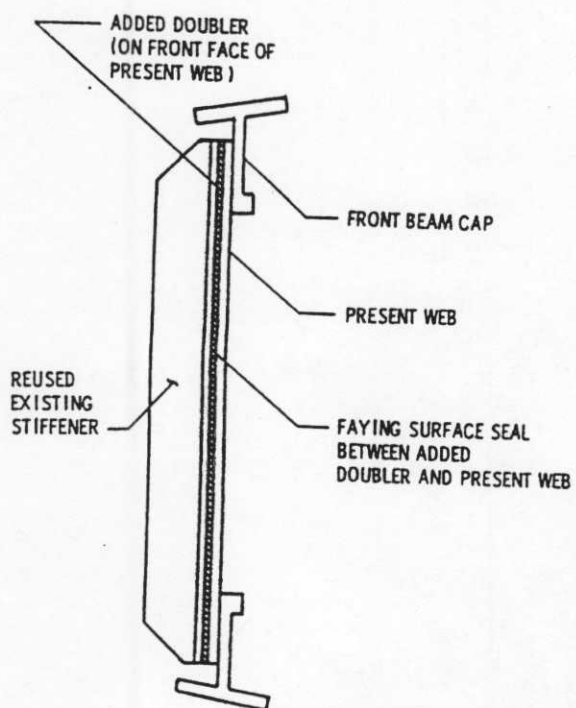
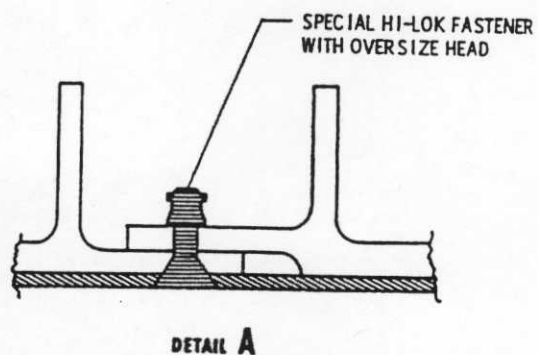
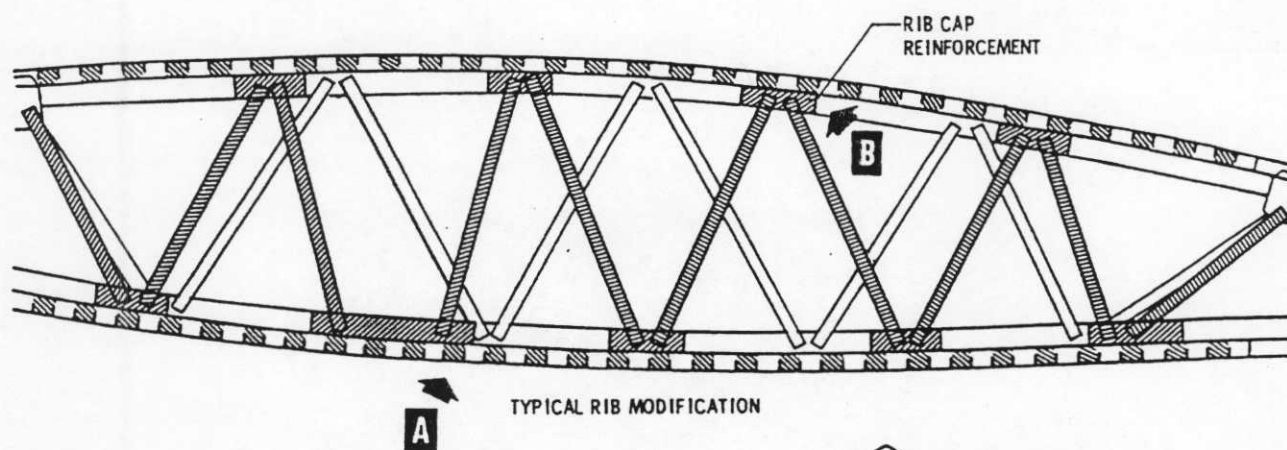
Wing Modification
Figure 2 (Sheet 2)

Approximately 80 percent of the "H"-clip to rib cap attachments from W.S. 65 to W.S. 397 will be reworked to replace the two rivets nearest the skin with steel Hi-Lok fasteners.

5/32 HI-LOK FASTENER
REPLACES TWO AN470AD4 RIVETS
NEAREST SKIN ON 80% OF CLIPS
BETWEEN WS65-WS397
WHERE CL'PS ARE REPLACED
ALL FASTENERS WILL BE HI-LOCKS

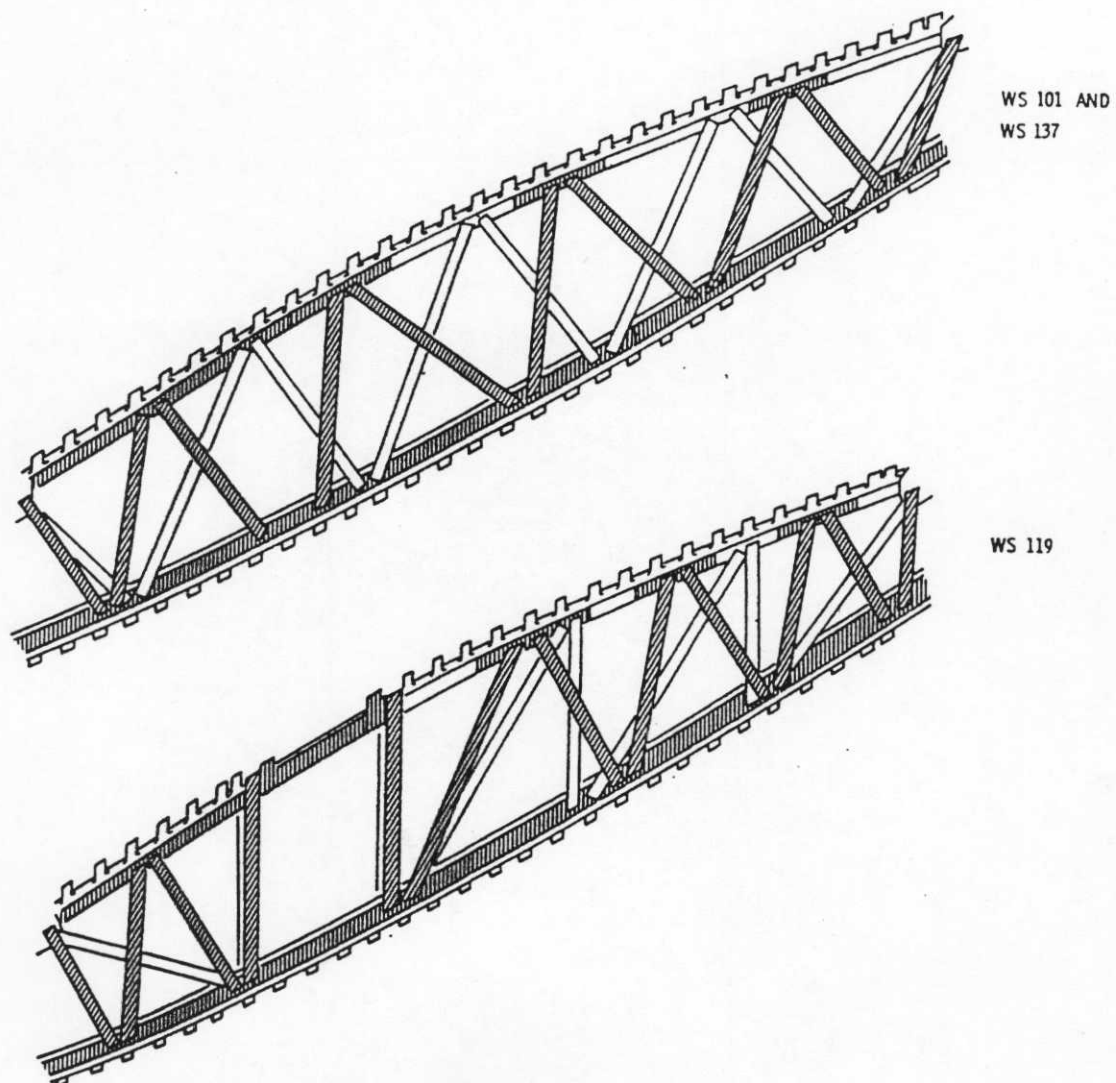
The wing ribs are being improved even though previous wing rib damage was incidental to surrounding structural failure when the airplane was involved in hard or crash landings. Actually the wing has good strength margins under any operating condition with any panel completely disconnected from more than one rib, a condition very much more extreme than reported by field service inspection. In keeping with the "wing strength insurance policy", rib changes will make rib deflection characteristics consistent with wing box distortions.

NO CHANGES, EXCEPT FOR RIB CAP TAB CHANGES FOR ATTACHMENT TO
NEW NUMBER 3 UPPER PANEL., ON RIBS AT FOLLOWING WING STATIONS:

W. S. 414, 431, 448, 465, 482, 499, 516, 533, 550, 567

NO CHANGES TO RIBS OF WING CENTER SECTION

Nineteen ribs between W.S. 65 and W.S. 397 will have diagonal member changes. Three new extrusions are required for this modification. The diagonal extrusion will be similar to the present diagonal but of a heavier cross section. A new Z-extrusion will be used for doublers added between the new diagonals and the rib caps. Some caps will be replaced with new section extrusions where the length of the Z-member becomes too long to be practical. The outboard nacelle ribs at W.S. 346 and W.S. 380 are strengthened by adding shear webs to the forward rib portions in lieu of bracing.

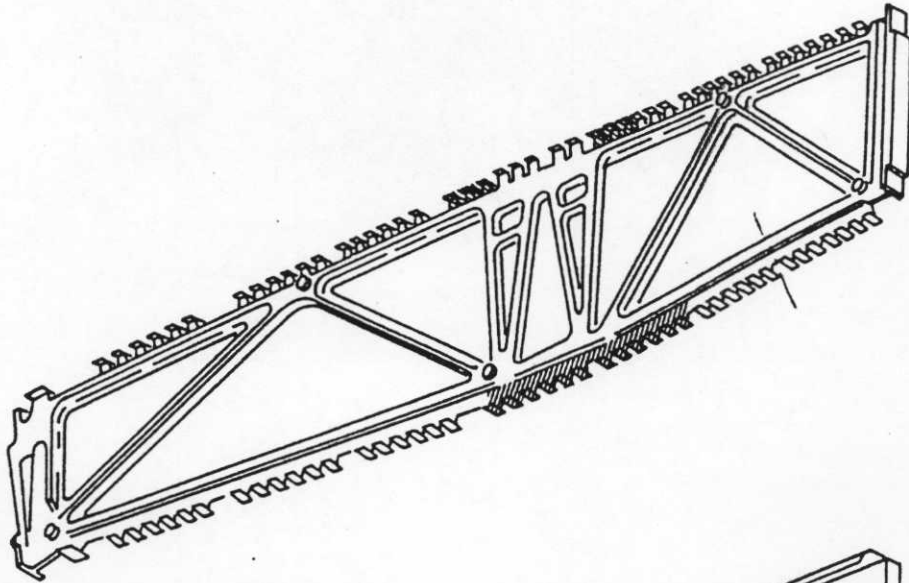
WS 167 AND WS 209
MAIN LANDING GEAR
RIBS SB 503

Two new extrusions will be used for this change. Reinforcing clips, made from the new extrusions, will be added on the top and bottom ribs. Clips will be added to those tabs near the landing gear trunnion. Approximately 6 tabs on the bottom of each rib and 12 tabs on the top of each rib are affected.

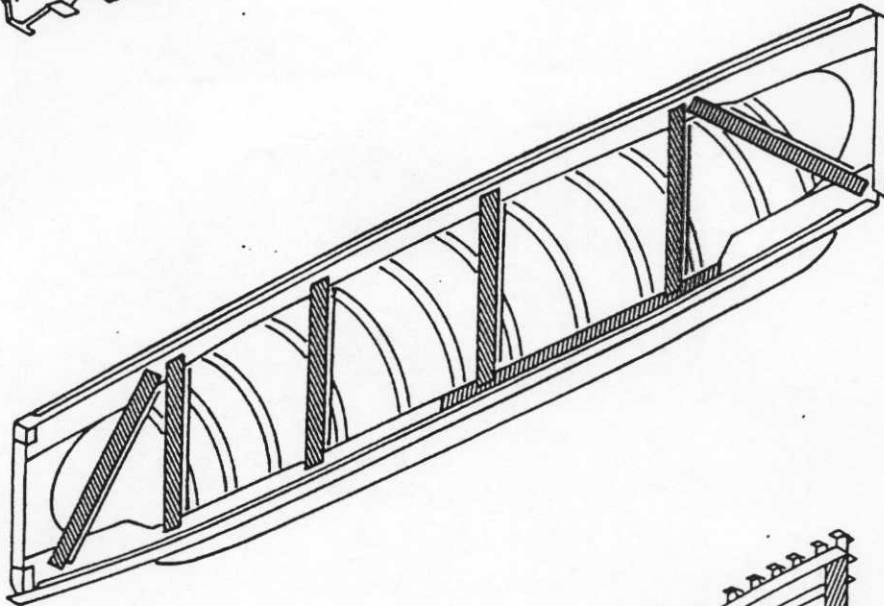
WS 155 AND WS 221
TANK RIBS

All posts at tank ribs are replaced with heavier members. The forward portions of the upper rib caps will be spliced to accommodate the new upper panel installation.

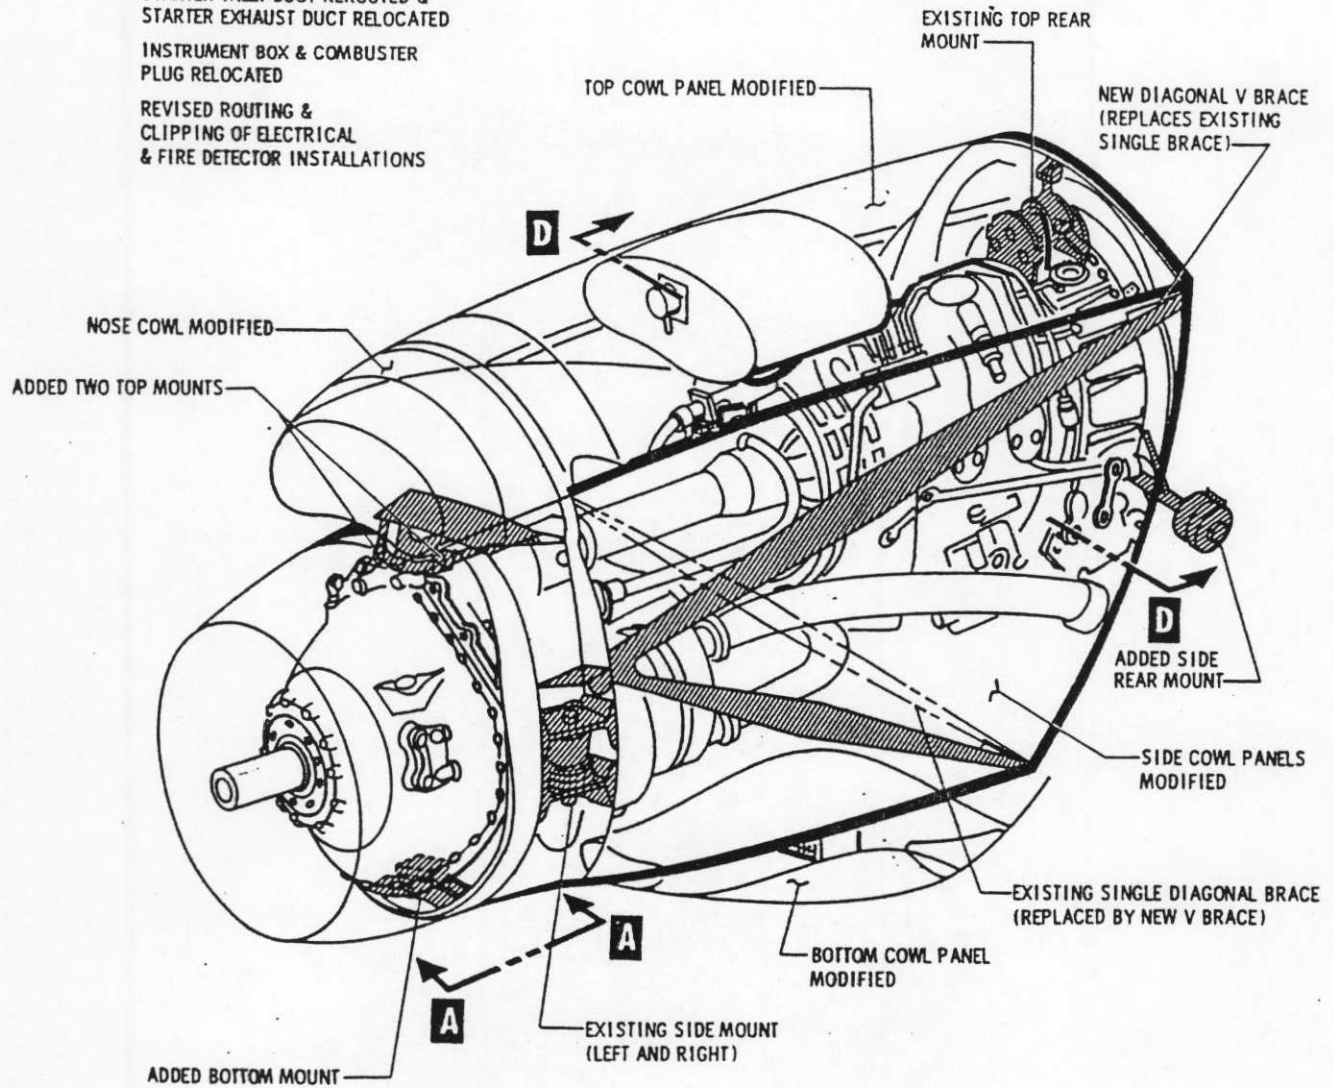
QEC Modification
Figure 4 (Sheet 1)

The engine mounting system is made "fail safe" by the addition of four auxiliary engine mounts. Three mounts, two at the top and one at the bottom, are added to support the engine gear box. The two existing gear box side mounts are stiffened. A mount is added on the left side of the engine below the existing engine rear mount at the top of the engine, which remains unchanged. The QEC structure is stiffened by replacing the single diagonal brace on each side of the QEC with a "V" brace and by changes to the nose, top, bottom, and side cowls. No changes to the basic engine structure are required. The nacelle structure aft of the QEC is stiffened primarily by changes to the longerons and fittings that carry the loads between the QEC and the wing.

ENGINE - MOUNTED COMPONENT
CHANGES DUE TO BRACE INTERFERENCE:

EDC SURGE RELIEF VALVE
ROTATED & INLET DUCT
CONTOURS REVISED

OIL TRANSMITTER BRACKET RELOCATED

STARTER INLET DUCT REROUTED &
STARTER EXHAUST DUCT RELOCATED

INSTRUMENT BOX & COMBUSTER
PLUG RELOCATED

REVISED ROUTING &
CLIPPING OF ELECTRICAL
& FIRE DETECTOR INSTALLATIONS

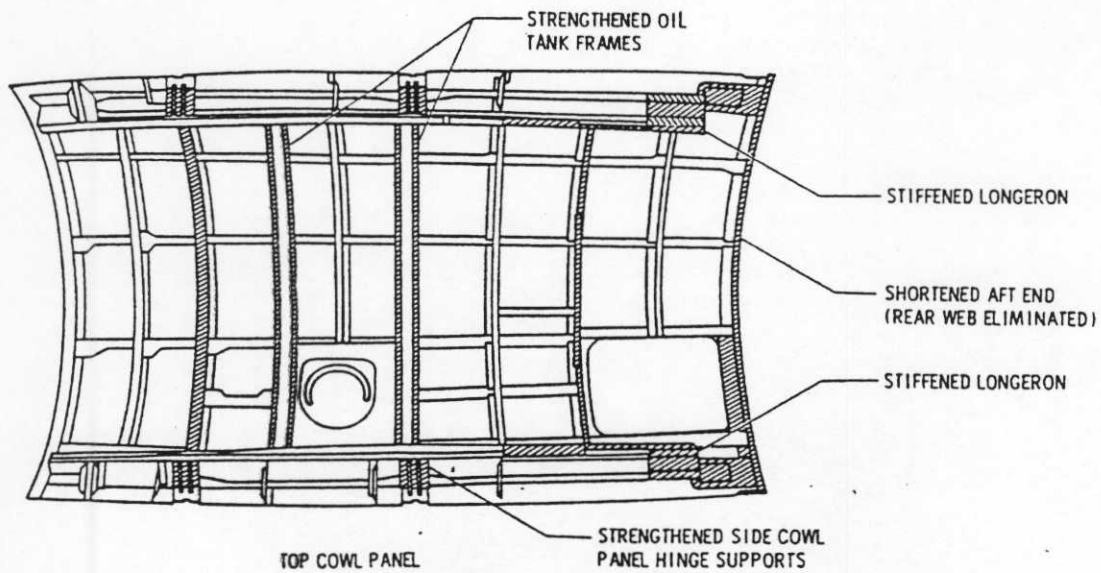
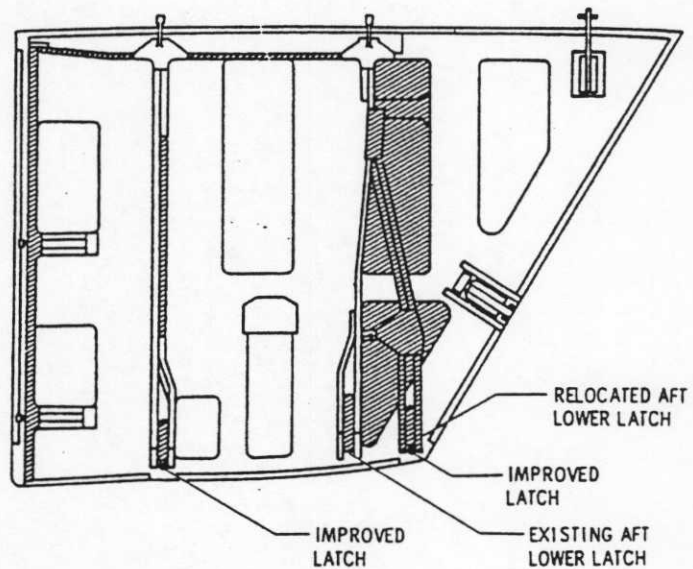
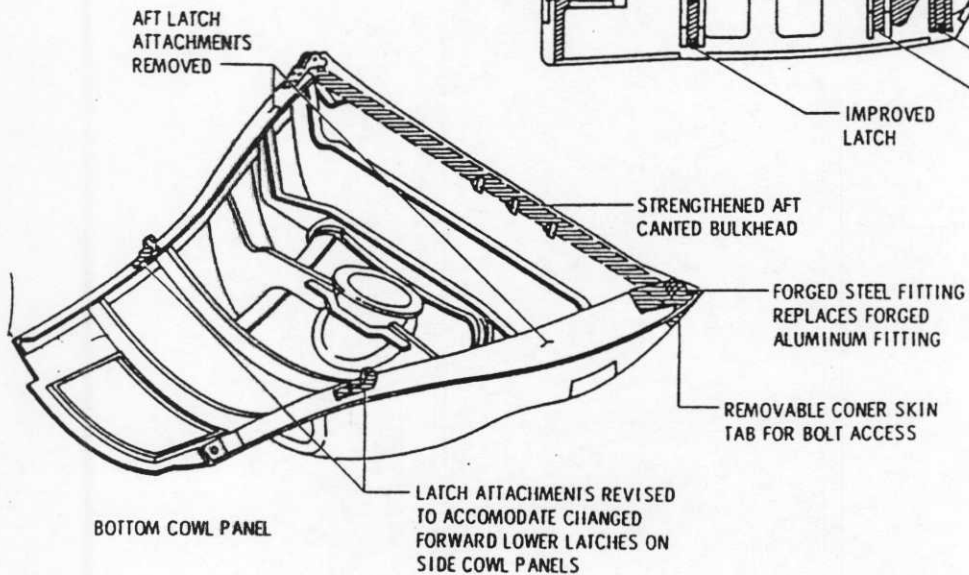
QEC Cowl Modification
Figure 6

The top cowl panel is modified primarily to permit this panel to be removable, providing access to and removal of the engine oil tank. The existing panel is not removable, since the oil tank below the panel was removable through the side cowl opening with the rear engine mount attached to the rear web of the top cowl panel. However, the location of the upper half of the "V" brace now precludes tank removal from the side. The top cowl panel is made removable by attaching the top rear mount to a new QEC rear beam. The shortened panel is fastened to this separate beam, with the ends of the beam attached to the two upper aft brace fittings. A ground handling support is required to stabilize the rear mount when the top cowl panel is removed, since the upper QEC longerons and side cowl panels are not in place. Other changes to the top cowl panel include stiffened longerons, strengthened side cowl panel hinge supports, strengthened oil tank frames, and additional screw attachments to the nose cowl panel.

The two side cowl panels are modified to provide clearance between the panels and the "V" braces and to relocate panel mounted components mating with components relocated because of brace interference. The air starter exhaust, provided on airplanes containing the integral start system, is relocated because of brace interference. The lower aft latch and support rod are also relocated because of brace interference. The lower

aft latch now attaches to the lower aft brace fittings instead of to the bottom cowl panel. Both existing lower latches are replaced and panel structure is stiffened to provide greater panel retention under air loads.

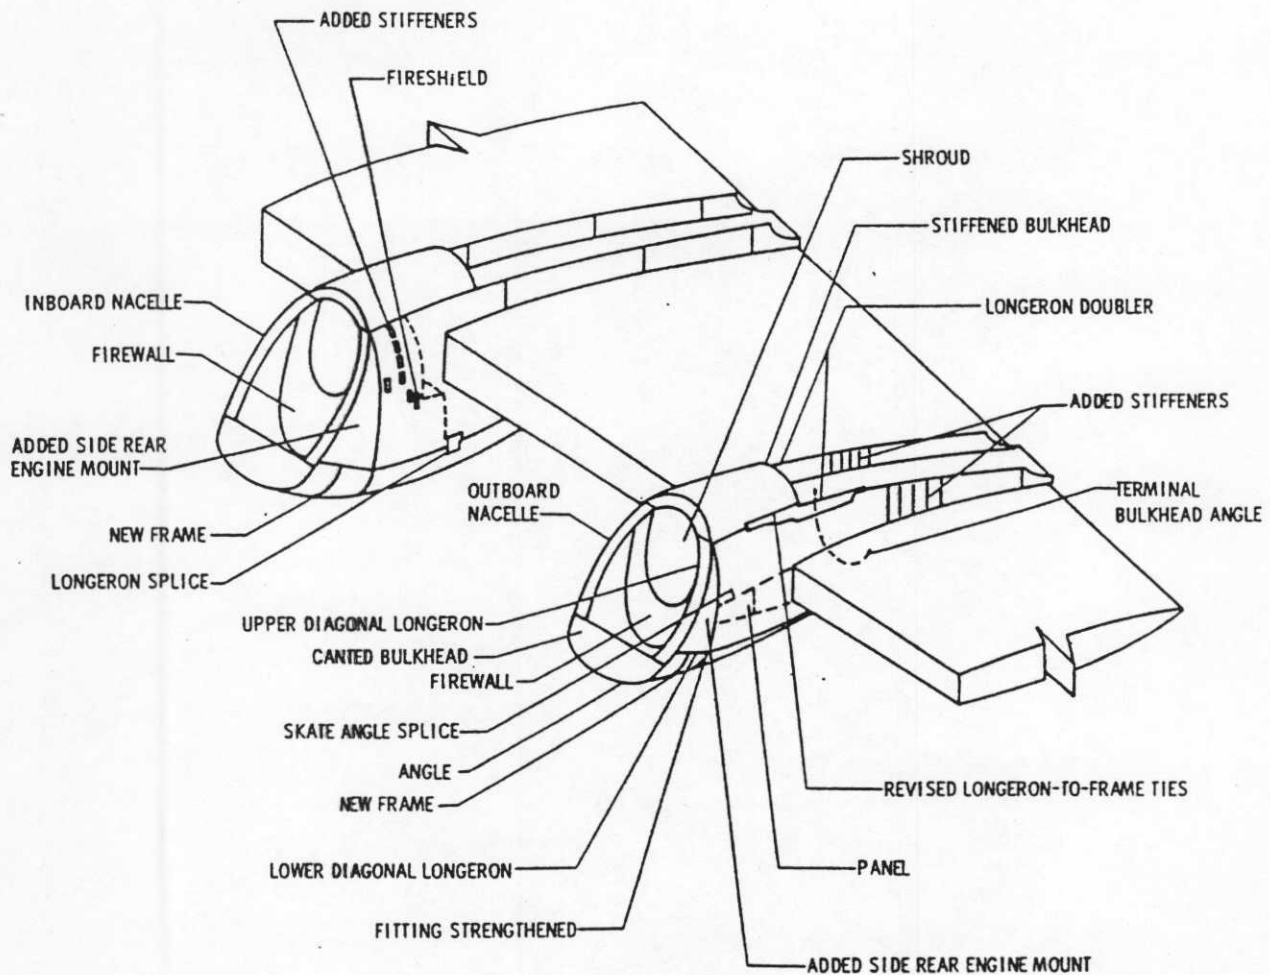
Nacelle Modification
Figure 7

Four new machined forged steel fittings, two at the forward ends of the left and right lower longerons and two at the aft ends of the left and right lower diagonal longerons are provided in the outboard nacelles only.

The left upper diagonal, left and right lower diagonal, and upper aft longerons in the outboard nacelles and the lower aft longerons in the inboard and outboard nacelles are modified. The left upper diagonal longeron in the outboard nacelles is stiffened by an added member. The lower diagonal longerons in the outboard nacelles are completely new. The upper aft longerons in the outboard nacelles are stiffened from the firewall to the region of the wing rear beam by the addition of one external and two internal straps. The lower aft longerons in the inboard and outboard nacelles are changed by an increase in the size of the splice angles in the region of the wing front beam. The forward ends of the lower aft longerons in the outboard nacelles only are changed to accommodate new fittings.

The side structure of the outboard nacelles is changed between the firewall and wing front beam by an added skin scab section, a skin section of increased thickness, and by strengthened skate angle splices, and the side structure between the tail-pipe cover and the center of the upper wing is modified by three added vertical stiffeners. The side structure of the inboard nacelles will incorporate more angles. The frame between the lower diagonal longerons at the center of the wedge section of the inboard and outboard nacelles is completely new. Two horizontal shelves are added to the left side of all nacelles in the wedge section forward of the firewall to support the added side rear engine mount. The firewall in all nacelles is stiffened by doublers added to some vertical members and webs. The bulkhead at nacelle station -0.49 between the upper aft longerons in the region of the wing front beam in the outboard nacelles is strengthened by added angles to the inner cap and larger attachments to longerons. The frames are cut and spliced on both sides of the inboard nacelles at nacelle station 9.50 to permit nacelle removal without cutting wires. The terminal bulkhead at nacelle station 35.81 at the lower rear of the outboard nacelles is strengthened by added angles. Various other minor changes are made to the nacelle structure.
